Property Inspection Report

727 Fairview Ave Unit C, Arcadia ,
Inspection prepared for:
Agent: Jeffrey Wung - Coldwell Banker Residential Brokerage

Inspection Date: 8/28/2007

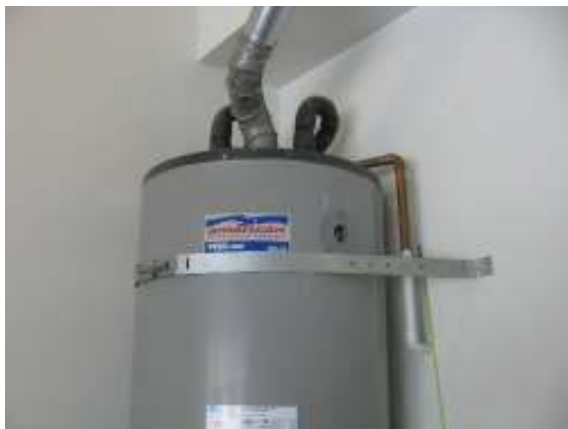
Waterheater - View

Observations: functional, recommend a drip pan

Materials: **gas**
Observations: operated

Observations: 50 gallons

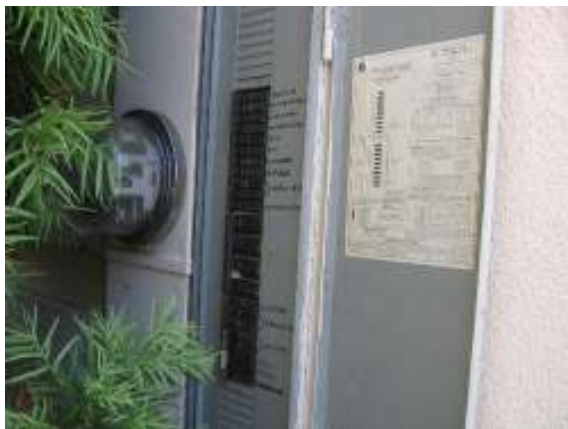
Electrical - Service Panel

Main Location: , south side
Observations: functional

Observations: 200 amp

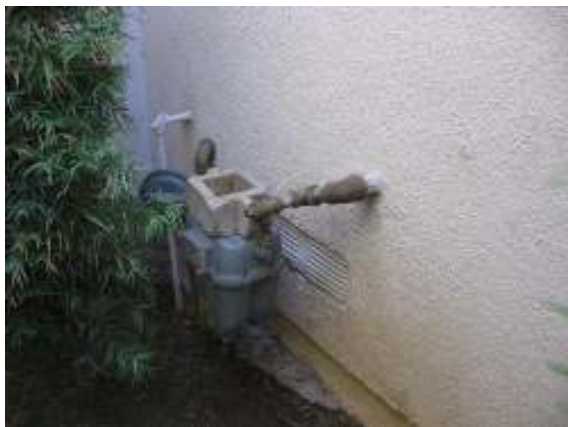
Exterior - Gas Main

Observations: natural gas, no seismic shut off present

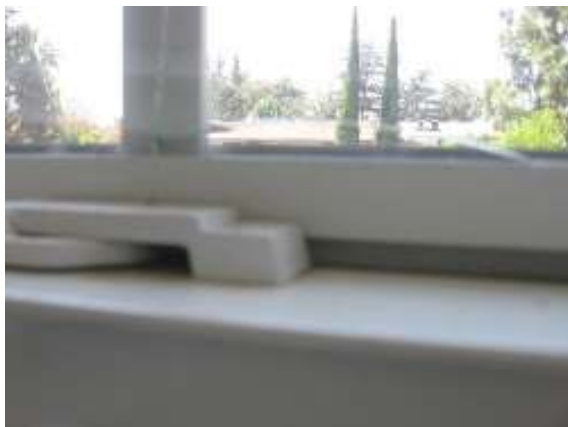
Bathroom - Window#2

Materials: **aluminum**
Observations: functional, **cracked glass in the#2 Jack & Jill bathroom upstairs**

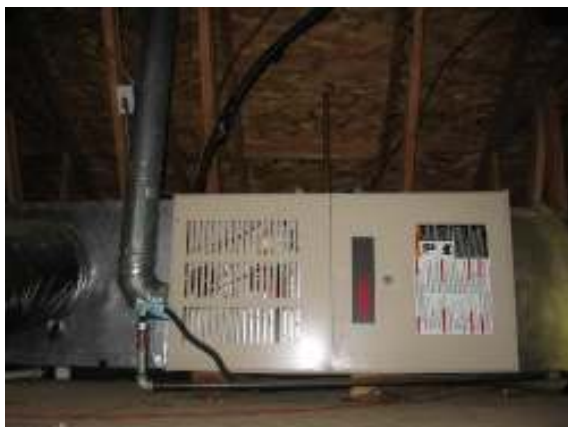
Heater - View

Location: , attic
Materials: **gas, forced, split system**
Observations: operated, Limited Inspection Only exterior temp is 97 degrees

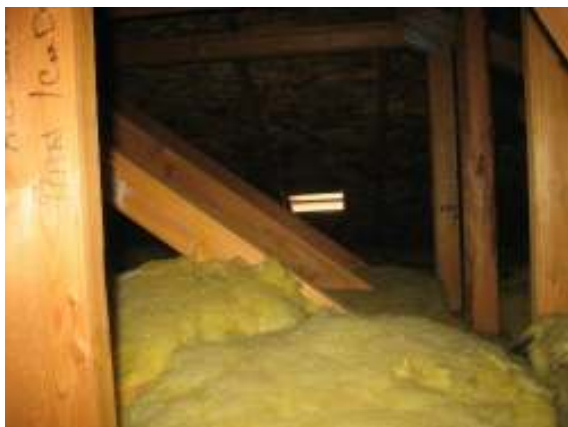
Attic - View

Observations: functional, some ducting is not accessible

Observations: most electrical is not accessible due to insullation

Materials: fiberglass batts
Materials: 12, inches
